MSP430F2410 Device Erratasheet

1 Revision History

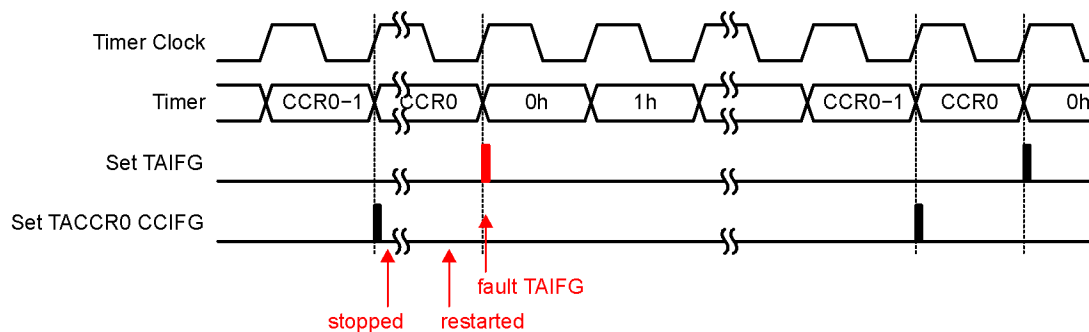
TA21 *TIMER_A Module*

Function TAIFG Flag is erroneously set after Timer A restarts in Up Mode

Description In Up Mode, the TAIFG flag should only be set when the timer resets from TACCR0 to zero. However, if the Timer A is stopped at TAR = TACCR0, then cleared (TAR=0) by setting the TACLr bit, and finally restarted in Up Mode, the next rising edge of the TACLK will erroneously set the TAIFG flag.

Workaround None.
