Stellaris[®] LM3S9U96 RevA1 Errata

This document contains known errata at the time of publication for the Stellaris LM3S9U96 microcontroller. The table below summarizes the errata and lists the affected revisions. See the data sheet for more details.

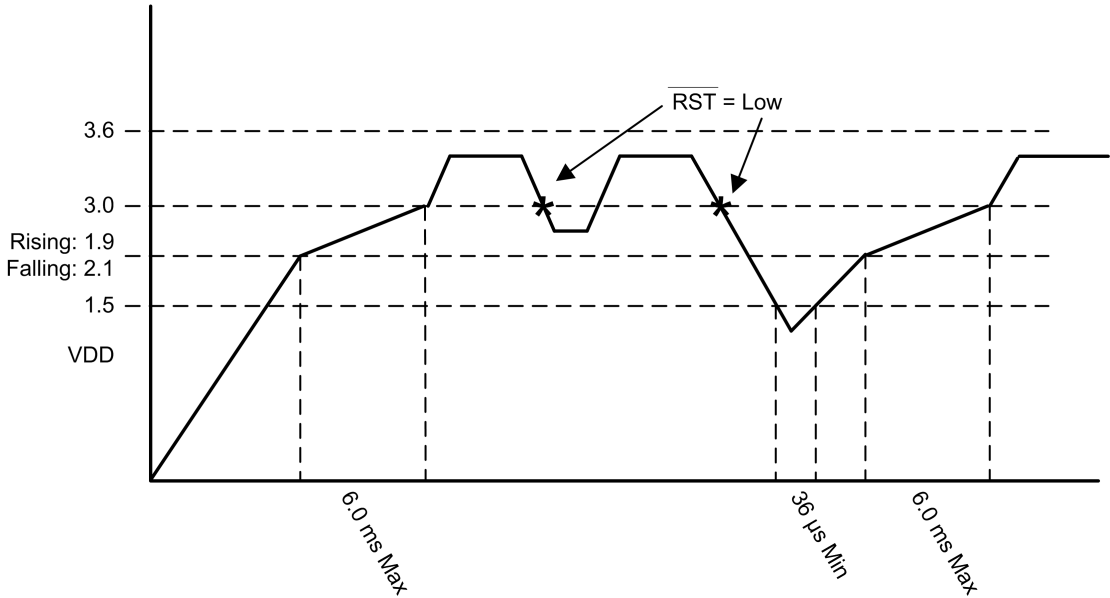
Figure 1. VDD Waveform Signature Limits

Depending on the system environment requirement, items 3, 4, and 5 in the above list may be met by using a voltage supervisor, such as the TLV803M, to monitor a higher voltage rail from which the VDD supply is regulated. Figure 2 on page 15 shows this implementation with a voltage supervisor monitoring the 5-V rail and a voltage trip point of 4.38 V. A voltage supervisor with a lower voltage trip point can be used to monitor the VDD (3.3-V) rail, however this supervisor must assert reset before VDD reaches 3.0 V. Regardless of the implemented voltage supervisor circuit, the system designer must ensure that there is enough time to assert $\overline{\text{RST}}$ Low prior to VDD falling below 3.0 V. Figure 3 on page 16 shows the resulting waveform of the circuit shown in Figure 2 on page 15.

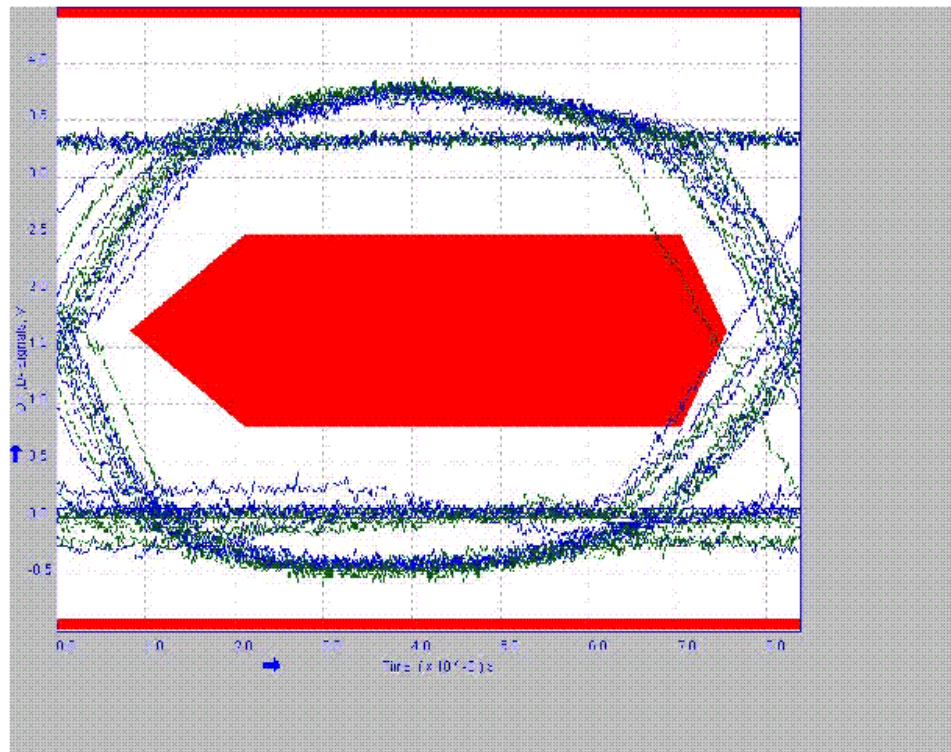
Figure 10. Example of USB Certification Failure

If the EPI module is operating, the USB interface may fail USB certification. Failures have been seen for the eye diagram and jitter (see Figure 10 on page 43). Because of these issues, there is a potential for data corruption on the USB interface when using the USB and EPI at the same time. The risk of data corruption is small, but is dependent on the system design.

- Signal eye:
Eye Diagram Test fails

- EOP width: 169.0995ns
EOP width passes
- Receivers: reliable operation on tier Tier 6
Receivers pass
- Measured Signalling Rate: 11.92707Mbps
signal rate conditionally passes
- Crossover voltage range: 1.546667 V to 1.680000 V
Mean crossover = 1.615889 V
First crossover at 1.660000 V(11 other differential crossovers checked)
crossover voltages pass
- Consecutive jitter range: -165.1885ns to 1.811468ns, RMS jitter 52.27256ns
Paired JK jitter range: 752.3810ps to 2.871429ns, RMS jitter 1.821542ns
Paired KJ jitter range: 1.185714ns to 2.168571ns, RMS jitter 1.695397ns
jitter fails

USB certification can be attained if an application does not require the USB and the EPI to be operating simultaneously. Customers who do not intend to pursue USB certification should determine if their application can handle the resulting small amount of error.
